Attachment 9.1 Facilities Audit

Town of Shelburne

As part of the Town of Shelburne Self-Evaluation, the following facilities were evaluated:

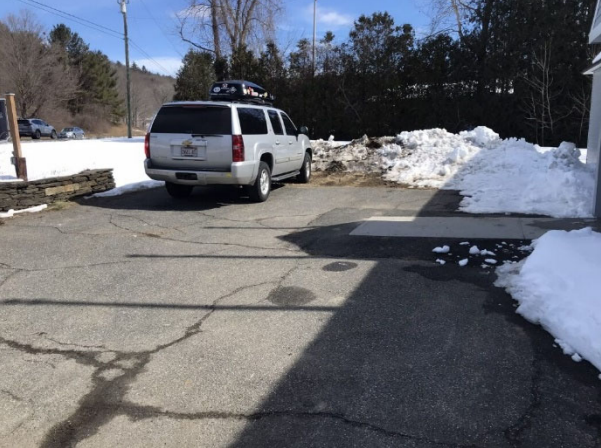
| # | Barrier to Access | Reference | Photo | Corrective Action |
|---|---|---|---|--|
| 1 | Lack of Signed Parking | 502.6- Identification | | Add parking signage. |

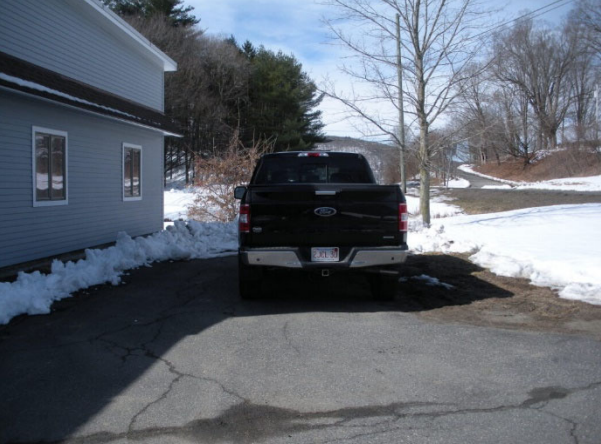
| # | Barrier to Access | Reference | Photo | Corrective Action |
|---|---|---|---|--|
| 2 | Lack of Site Arrival Point | 206.2.1 | | Provide accessible route from accessible parking spaces to accessible building entrance. |

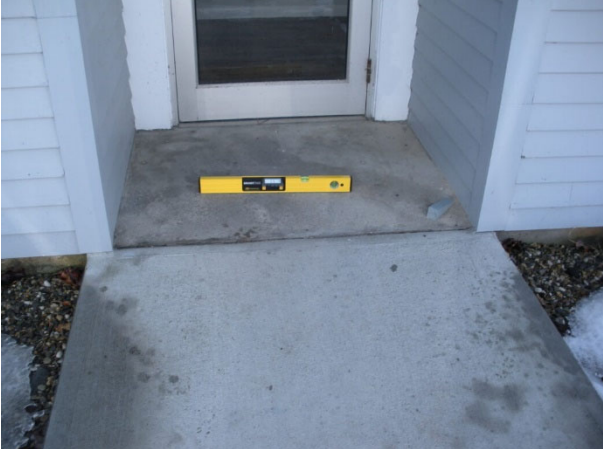
| 3 | Lack of Level Landing | 405.7 | | Level landing needed at accessible door. Remove and repour landing. |

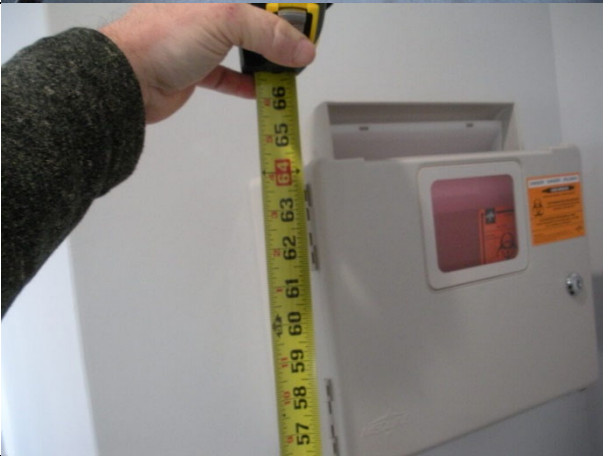
| 4 | Reach Range | 308.2 | | Reach range for documents and syringe disposal is 15" (low) to 48" (high). Relocate disposal container and brochure holder. |

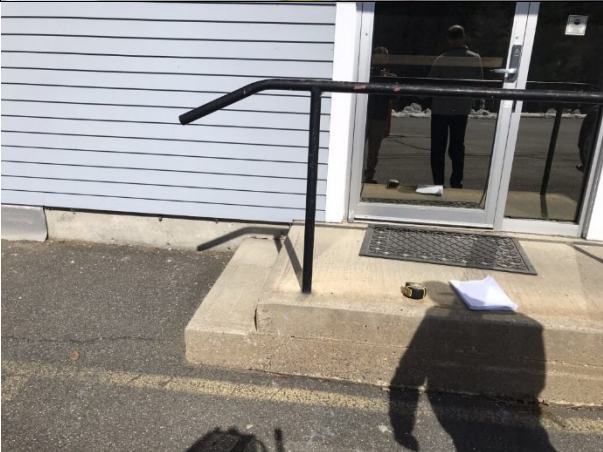
| 5 | Lack of Handrail on Rear Exit Steps | 505.10.3 | | Extend rail one foot beyond last stair tread. |

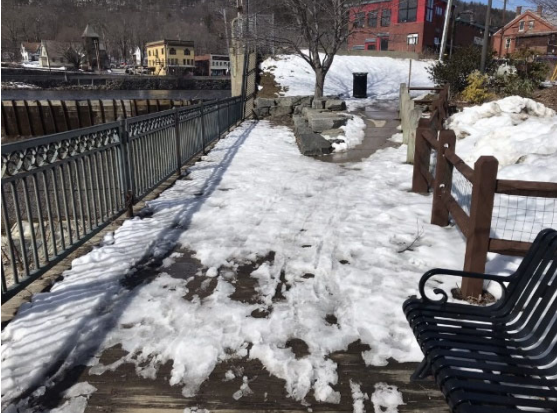
| 2 | Non-Accessible Route | 401.1 | | Ensure that accessible route is kept clear. |

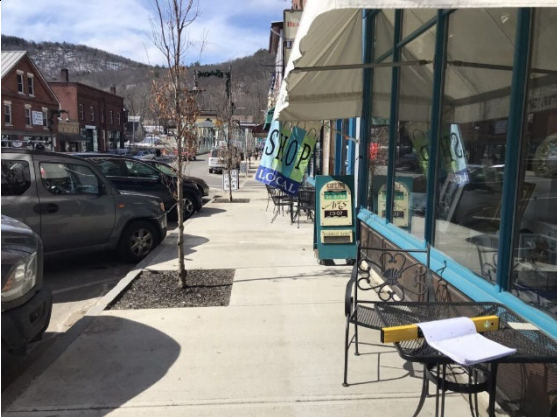
| 4 | Storefront Awnings Extend Below 80"; Leading Edges Not More Than 80" Above the Finish Surface Cannot Protrude More Than 4" Horizontally Into the Circulation Path | 307.2 | | Assume that awnings will not be removed. To ensure clear width for passage along a sidewalk beyond the leading edge of the awnings install tree well grates and limit other objects such as sandwich sign boards and newspaper boxes. |

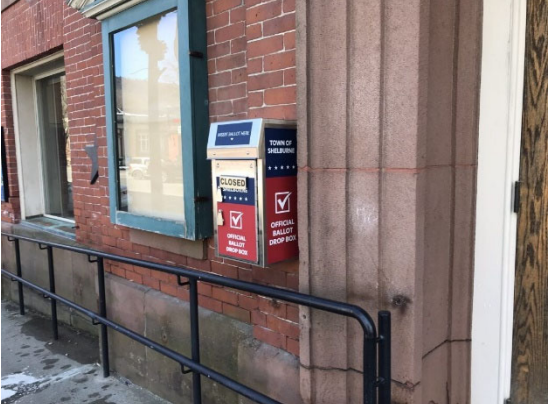
| 2 | Ballot Box Should be Located on Level Landing Area | (Need to find cite) | | Provide level surface for use of ballot box. |

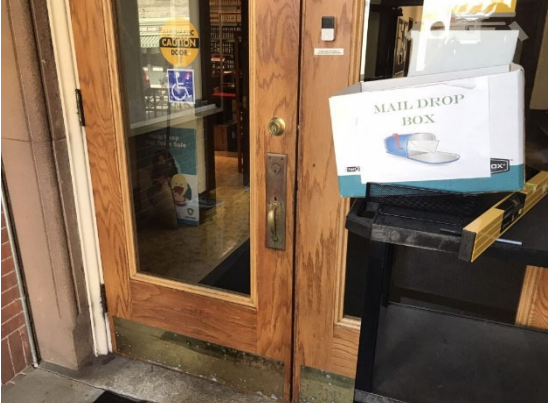
| 4 | Shelf Placed Within 18" of Latch Side of Door Which Can Impede Travel | 404.2.4.1 | | Relocate shelf to ensure adequate maneuvering clearance at door. |

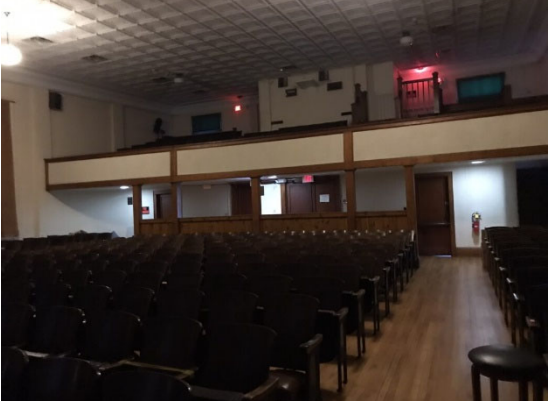
| 5 | Auditorium Handrails | 505.10.2; 505.10.3 | | Extend handrails 12" beyond top and bottom stair treads |

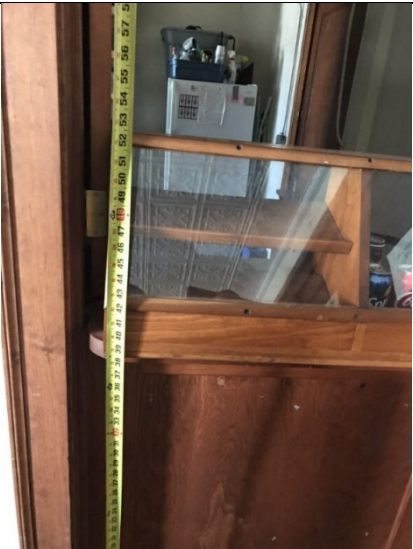
| 6 | Sales and Service Concession Counter Height | 904.4.4 | | Adjust counter to meet prescribed height |

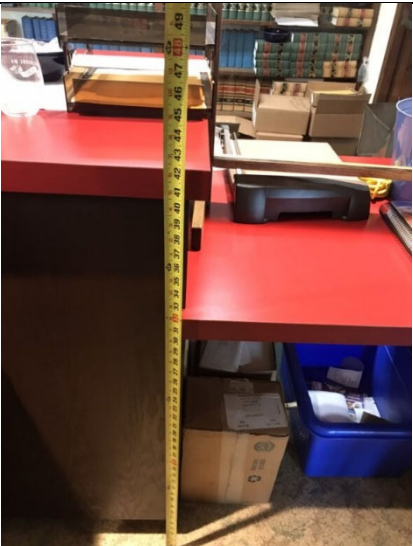
| 8 | Clerk's Office Access | (need cite) | | Remove boxes and relocate furniture so as not to impede access |

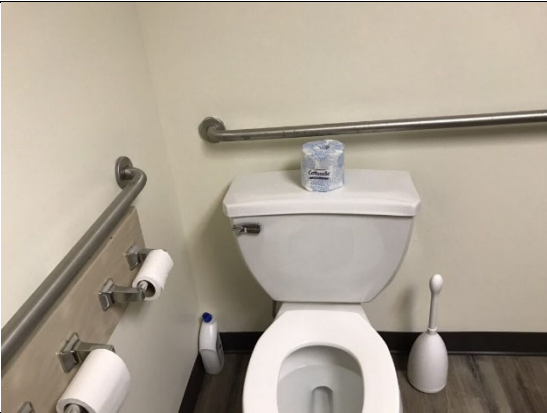
| 9 | Women's Room – Toilet Paper Dispenser and Toilet Handle | 604.7; 604.6 | | Relocate toilet paper dispenser in front of water closet. Toilet handle to be on open side of tank. |

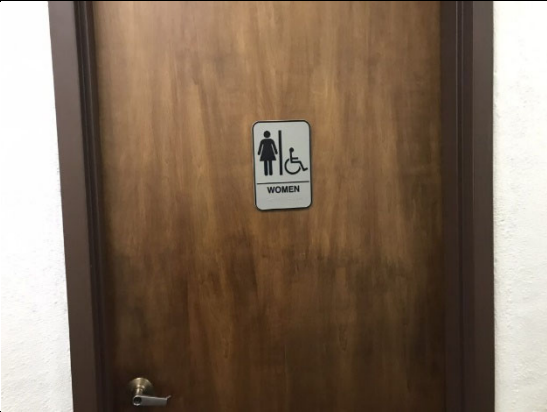
| 11 | Bathroom Signage and Use | | | Replace sign and make the bathroom a regular ladies' room. The accessible restroom is already Unisex and largely compliant. |

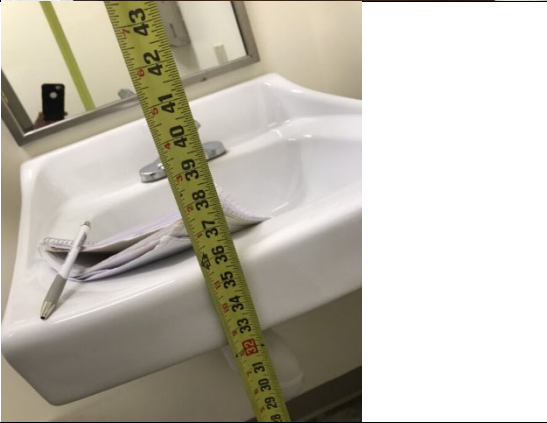
| 12 | Accessible Restroom- Sink and Mirror Too High | 606.3; 603.3 | | Sinks to be installed with the front of the higher of the rim 34" above finish floor. The bottom edge of mirrors shall be no higher than 40" above finish floor. |

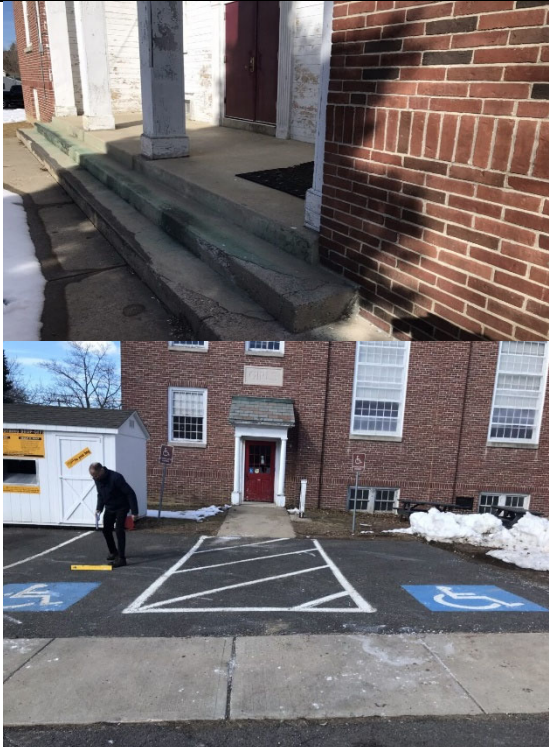
| Address | | 51 Maple Street, Shelburne, MA | | |
|---|--|---|---|---|
| 1 | Slopes At or Greater Than 5%; No Accessible Site Arrival Point From Right of Way | 405.2; 206.2.1 | | Install ramp with proper slope; provide accessible site arrival . |

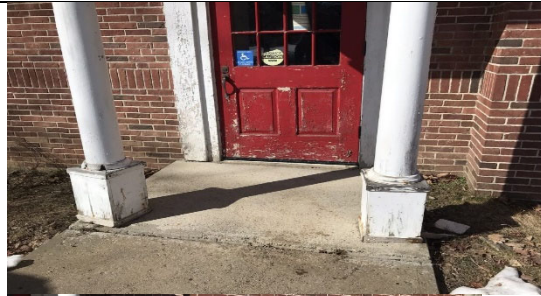
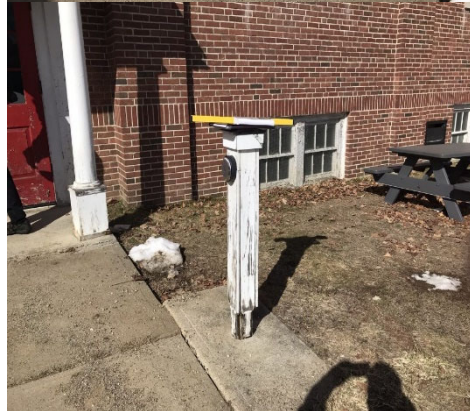
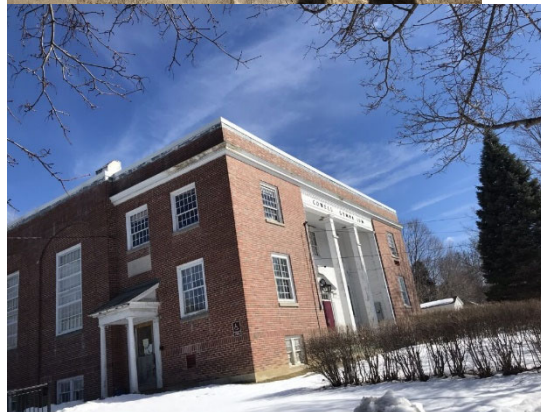
2

No Accessible Route From Parking Lot to Entrance; No 60" Landing at Door;

402.2; 502.3; 206.2.1; (need cite for 60" landing)

Demolish, form and pour new 60" concrete landing which will provide an accessible route to the building.

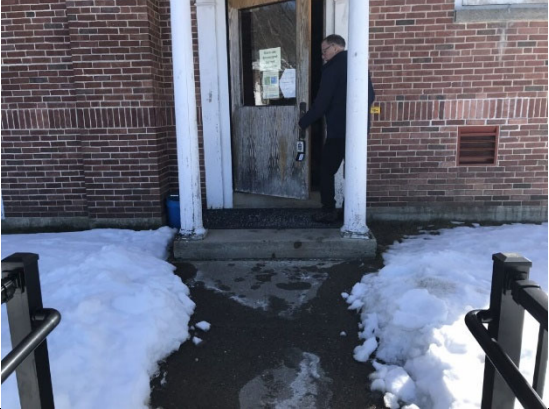
| 3 | Threshold Too High | 404.2.5 | | Provide proper threshold height. |

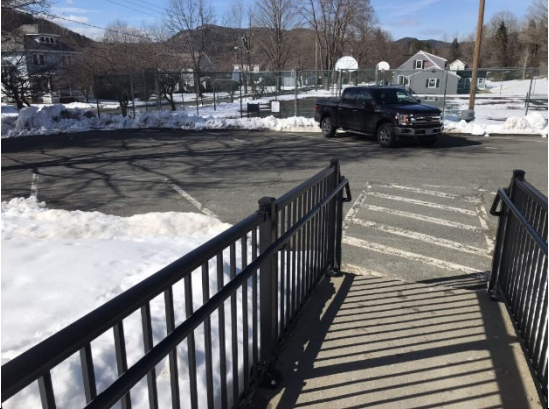
| 4 | 23 Rear Parking Spaces But None Marked Accessible; Front Handicap Spaces Non-Compliant | 502.5; 208.2.3.1; 208.2; 206.2.1 | | For 23 parking spaces provide 1 accessible spot with signage and stripping. |

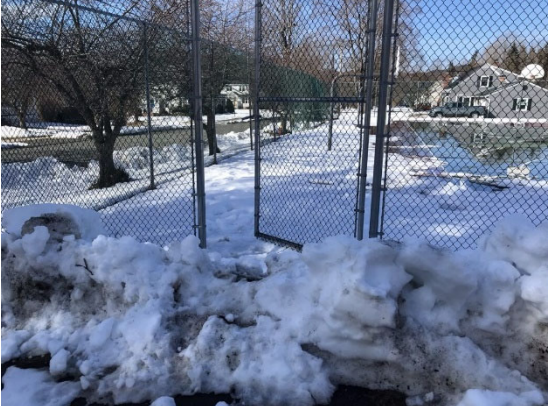
| 5 | No Accessible Route Connecting Basketball Courts With Building | 206.2.1 | | Provide marked accessible route across parking lot and maintain entrance for access. |

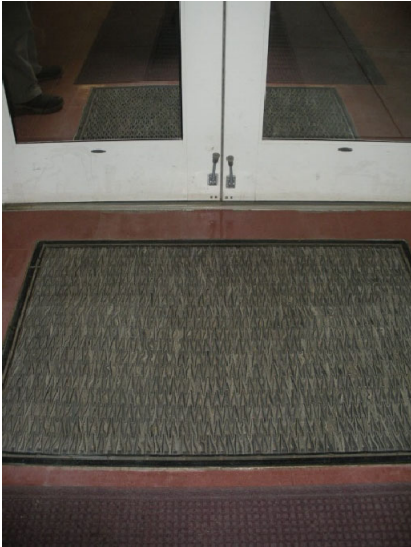
| # | Barrier to Access | Reference | Photo | Corrective Action |
|---|---|---|---|---|
| 1 | Doorstops Can Interfere With Footrests on Wheelchairs | 307.4 | | Consider installing door stops at 78" above finish floor. |

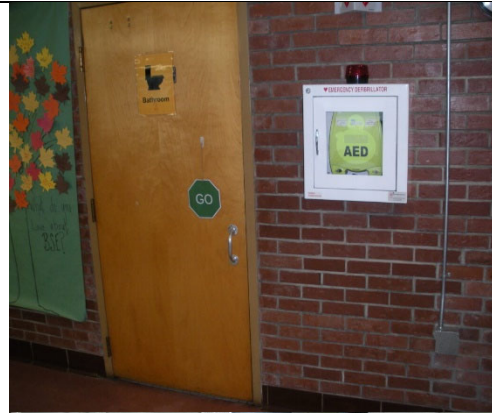
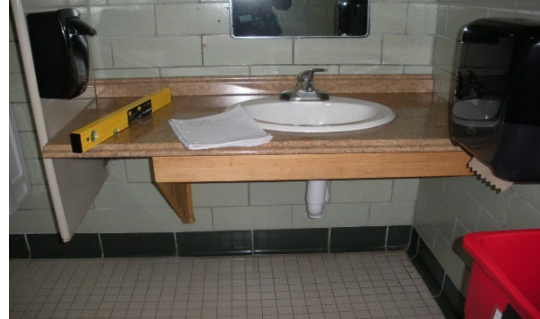
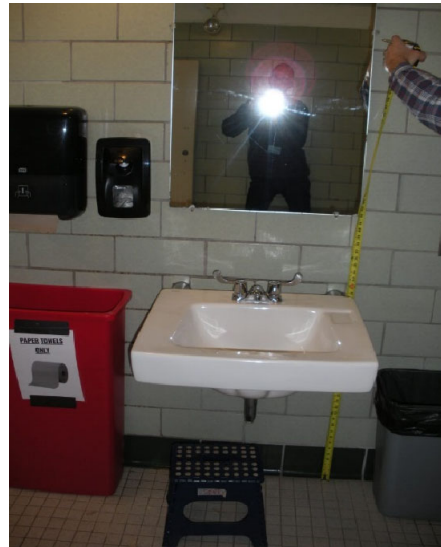
2

Lobby Restrooms - Mirror Height;
No Self-Closing Hinges; Latch On
Stall Door; No Signage; Sink
Insulation

603.3;
404.2.8.2;
604.8.1.2

Install appropriate signage on door; bottom
edge of mirror to be 40" above finish floor;
install spring hinges with proper closing
pressure; install pipe insulation under sink.

| | <p>(Continued)</p> | <p>404.2.8.2</p> | | <p>Install stall door latch assembly.</p> |

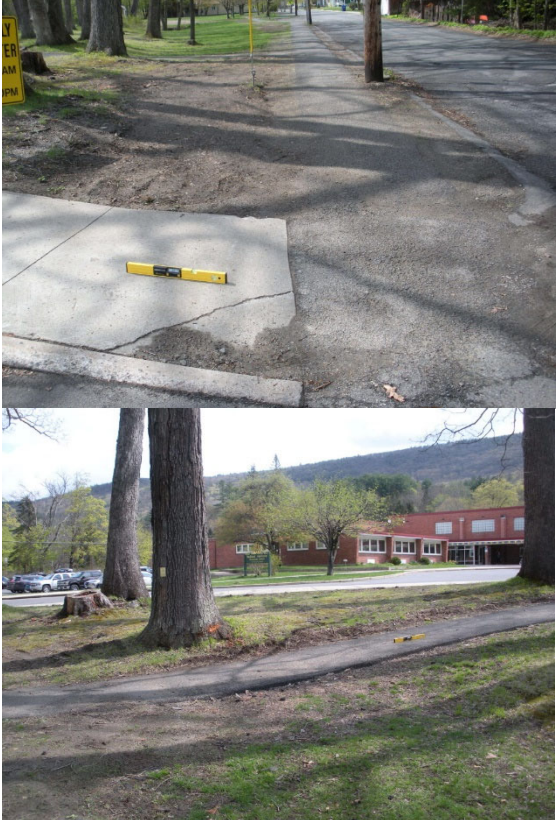
| <p>4</p> | <p>Site Arrival Mechanic Street- 4% Cross Slope- East Side; Segments of Asphalt Exceed 9% Slope; 9% Running Slope on Concrete Sections With Cross Slopes of Almost 5%</p> | <p>403.3; 402.2</p> | | <p>Cross slopes not to exceed 1:48; running slopes not to exceed 1:20. Replace sidewalks.</p> |

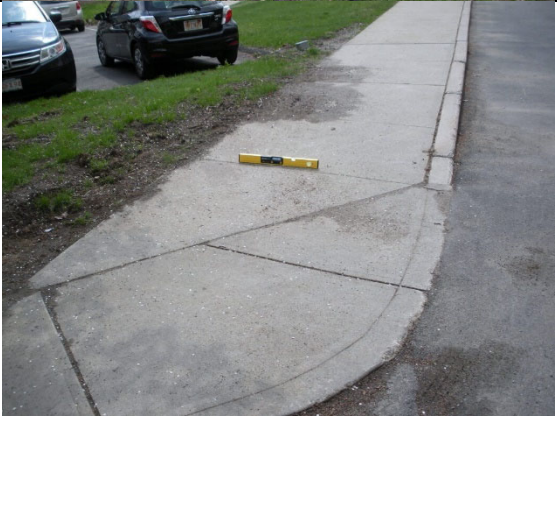
| <p>5</p> | <p>West Side of Driveway- Both Sides of Driveway at 8% Slope With 5% Cross Slope</p> | <p>403.3; 402.2</p> | | <p>Cross slopes not to exceed 1:48; running slopes not to exceed 1:20</p> |

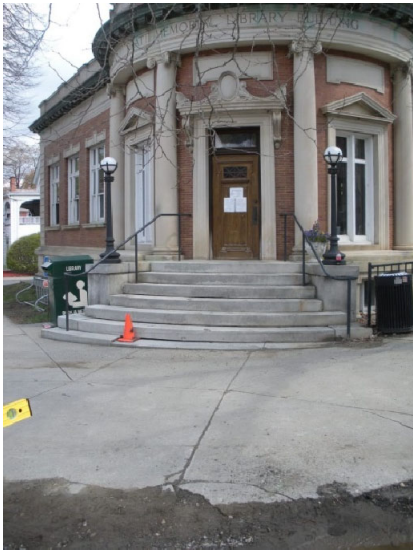
| # | Barrier to Access | Reference | Photo | Corrective Action |
|---|--|---|---|---|
| 1 | Handrails Do Not Extend Beyond Bottom of Extension of Stairs | 505.10.3 | | Install handrails that extend one tread depth beyond the last stair riser nosing. |

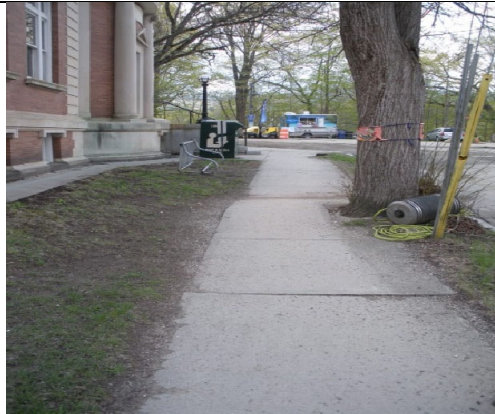
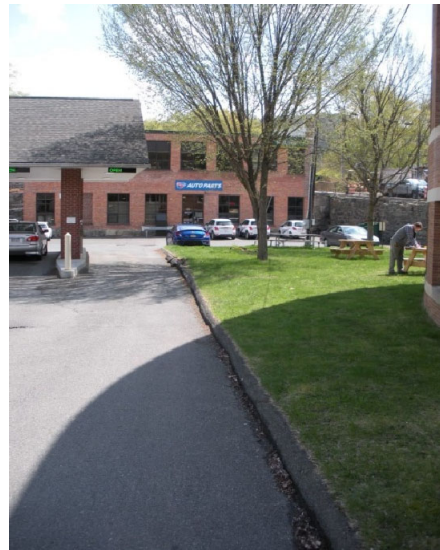
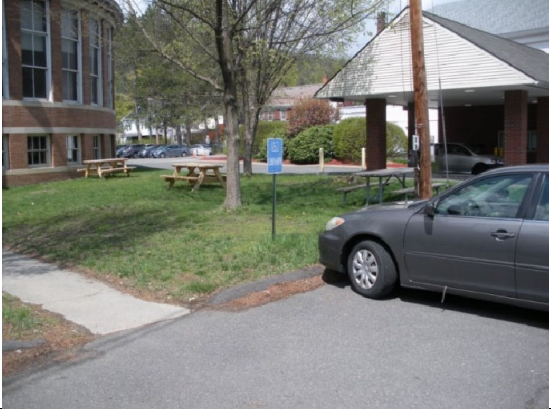
2

No Accessible Route From Front of Building to Rear Accessible Rear Entrance

402

Provide accessible route from front of the library and street right of way, down Bridge Street and along west side of library lawn to rear accessible entrance. The accessible route also would provide access to picnic tables at the rear of the library. An accessible route would negate the current system where travel is through the bank drive-through driveway since there is no sidewalk. The bank driveway includes speedbumps and deteriorated asphalt. It's unclear if the bank driveway is bank or Town property.

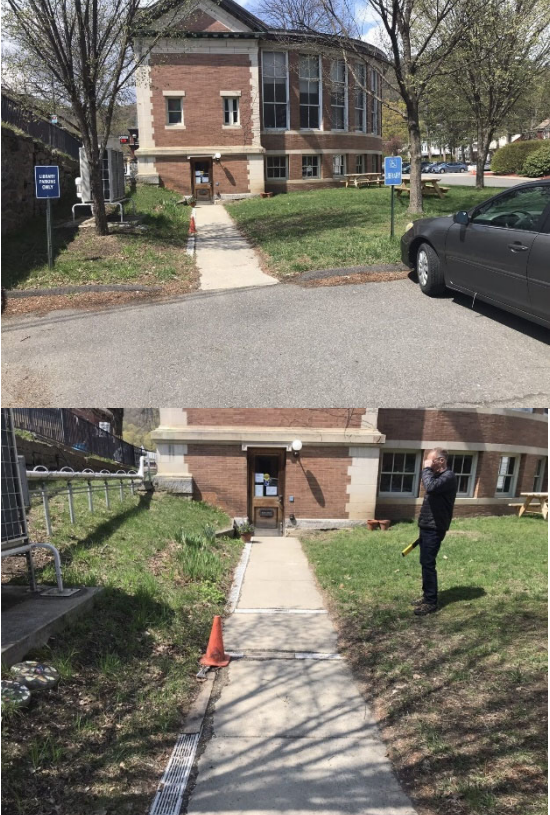
| 3 | <p>Rear Accessible Entrance- Need Signage for Rear Door; Walkway in Poor Condition; No Level Landing (2.4%); Flower Pot Obstructs Landing; Entrance Door at Lower Level Inoperable at Time of Audit</p> | <p>216.6; 405.7.1</p> | | <p>Install rear entrance sign with International Symbol of Accessibility. Repair rear sidewalk to ensure smooth route of travel from parking area to rear accessible door. Move flower pot which obstructs landing-walk. Replace landing at rear door to ensure</p> |

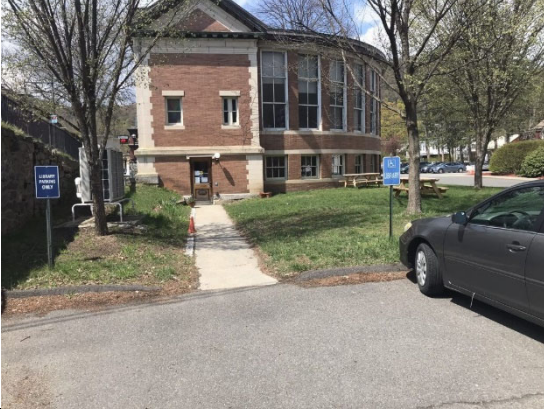
| 4 | Signage Not Compliant; No Parking Access Aisle; No Marked or Signed Van Accessible Space | 208.2; 502.2; 502.3; 502.3.3; 502.6 | | Add van accessible space with marked aisle; install applicable signage with International Accessible Symbol. |

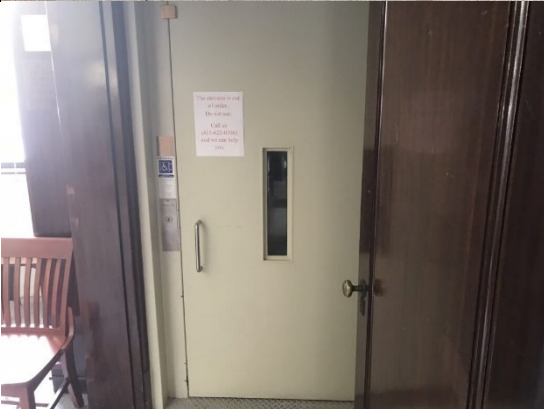
| 5 | Elevator for Accessibility Between Floors Not Operational | | | While the elevator was not operational at the time of the audit, the posted sign indicated that staff were available to assist patrons. |

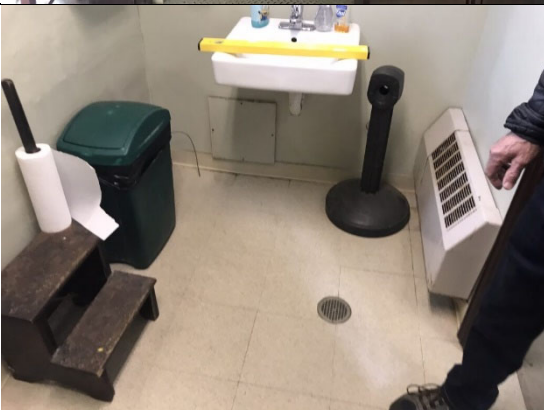
| 6 | Toilet Turning Space Not Provided | 304; 304.3.1; 603.2; 604.3.2 | | Remove objects to provide prescribed 60" turning radius in accessible bathroom. |

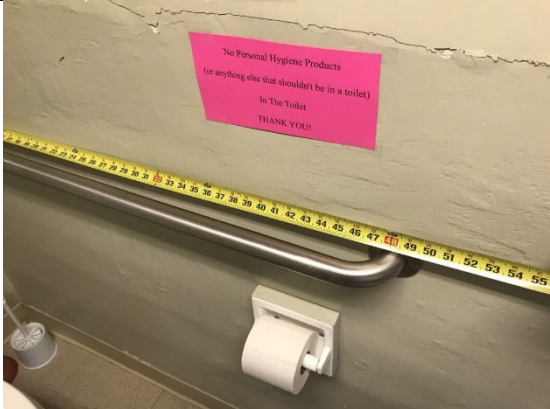
| 7 | Grab Bars- Sidewall Grab Bar Incorrectly Located | 604.5.1 | | Sidewall grab bar to be 42" long minimum, located 12" maximum from rear wall and extend 54" minimum from the rear wall. |

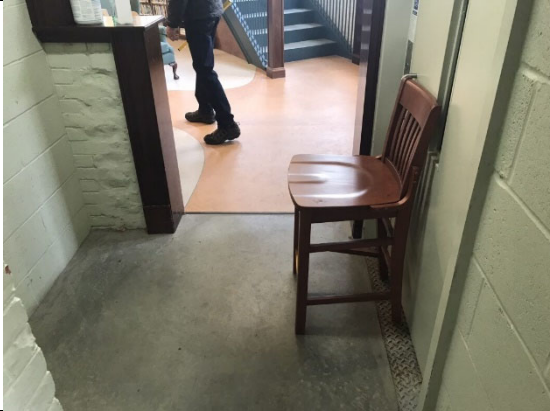
| 8 | Chair Does Not Allow for Required Clear Width and Accessible Path Between Rooms | 403.5.1 | | Remove chair from hallway. |

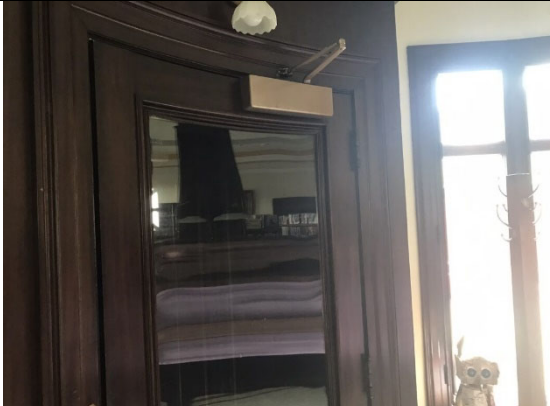
| 9 | Vestibule Door Requires 12 Pounds of Pressure to Open | 404.2.9 | | Adjust vestibule pressure to 5 pounds maximum. |

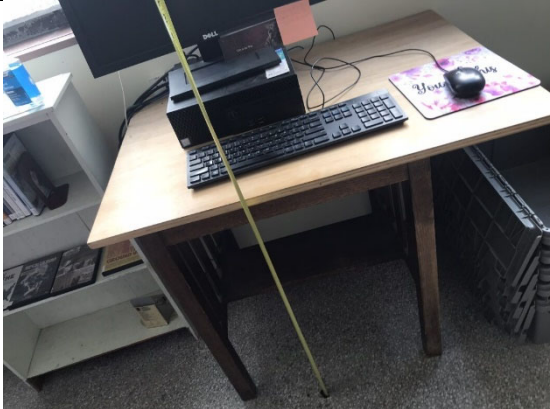
| 10 | Public Access Computer Desks Lack Clear Floor Space and Knee and Toe Clearance | 306.2; 306.3 | | Provide alternative table arrangements to meet minimum toe and knee clearances. |

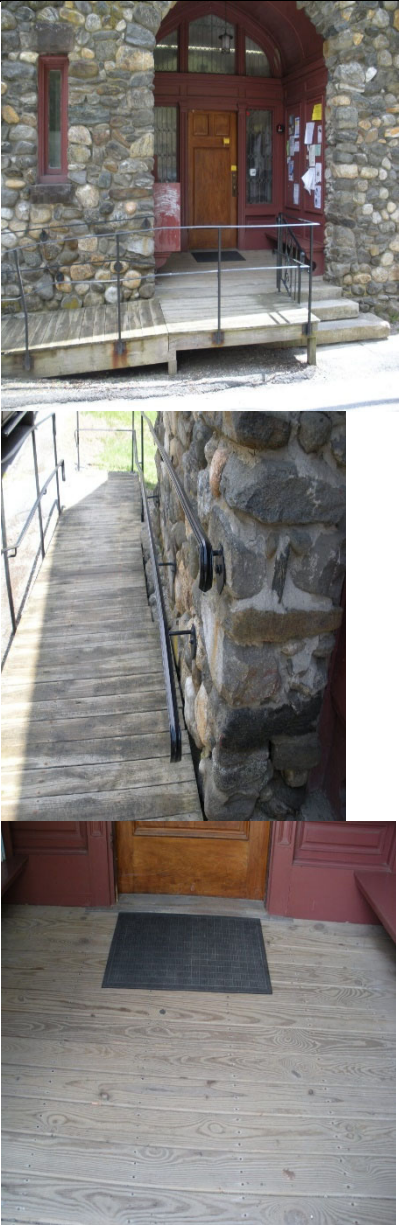
| # | Barrier to Access | Reference | Photo | Corrective Action |
|---|---|---|---|--|
| 1 | This is a non-compliant building. | | | <p>The Town should address this situation programmatically with a formal policy statement that shares programming between the two facilities. Such information can be put on the town website and in brochures. The focus should be to use the “program viewed in its entirety” allowance to say 50% of the libraries are accessible. Alternatively, the town can document and rely on historic exemptions (202.5)</p> |
